Subject: NPDES Permit No. **TNR111633**
 Bonny Oaks and Jersey Pike Mass Grading
 Chattanooga, Hamilton County, Tennessee

Compliance Inspection for General NPDES Permit for Stormwater Discharges from Construction Activities (CGP)

Site/Project Name: Bonny Oaks Dr. & Jersey Pike Mass Grading			NPDES Tracking Number: TNR111633	
Street Address or Location: Corner of Bonny Oaks Drive and Jersey Pike			Start date: 01-SEP-08	
			Estimated end date: 01-SEP-09	
Site Description: Mass Grading of property			Latitude (dd.dddd): 35.075278	
			Longitude (-dd.dddd): -85.192778	
County(ies): Hamilton	EFO: Chattanooga	MS4 Jurisdiction: Chattanooga	Acres Disturbed: 17.6	
			Total Acres:

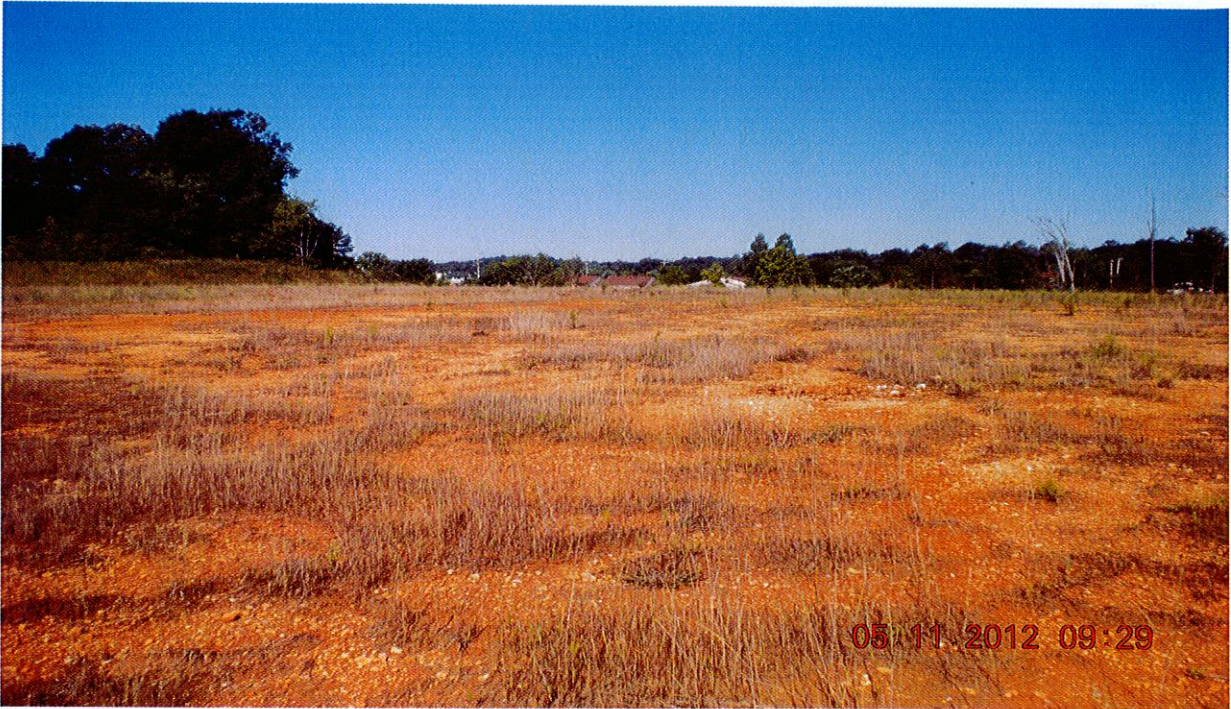
Photograph 1: Vegetative cover needs to be more complete and established. Properly stabilize bare soils throughout the site.

General Comments: Repair and restabilize gully in western sediment basin. Proper vegetative cover needs to be more established. Eastern sediment basin in not functioning properly and will require maintenance and use of flocculants. Please have repairs made by May 30, 2011.

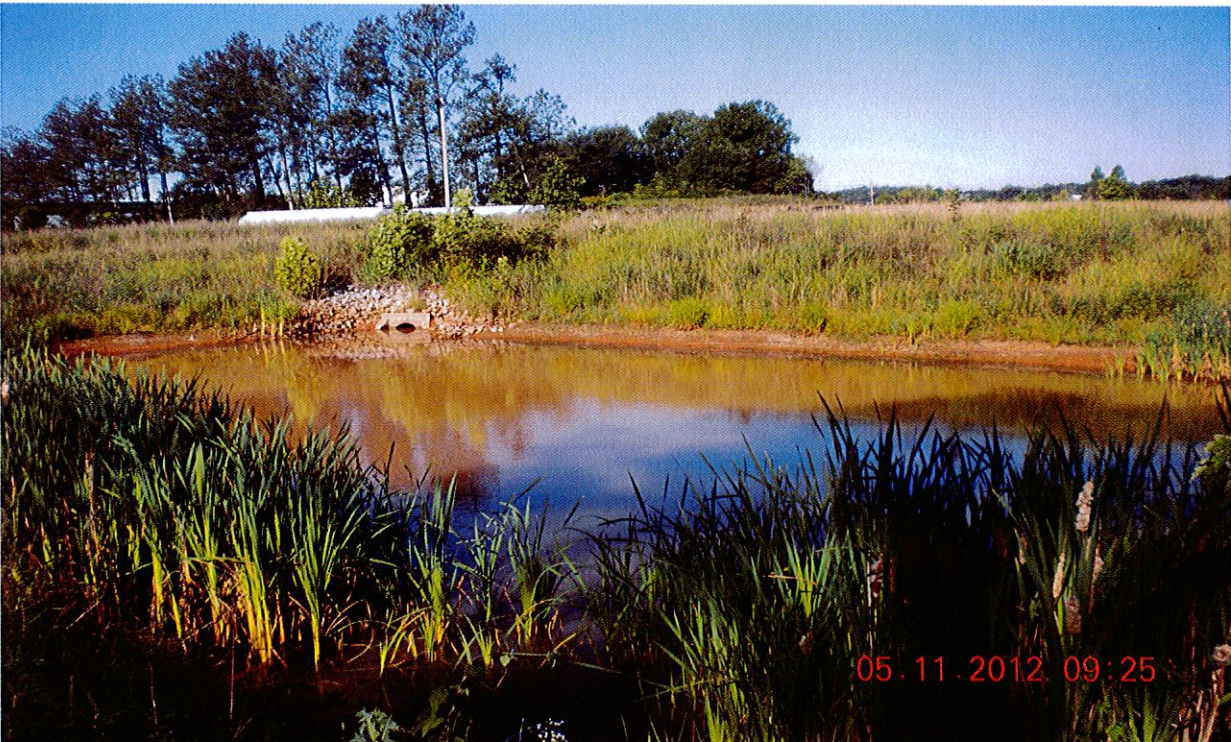
Photograph 2: Eastern sediment basin is in need of maintenance and flocculant treatments to help remove suspended clay particles.

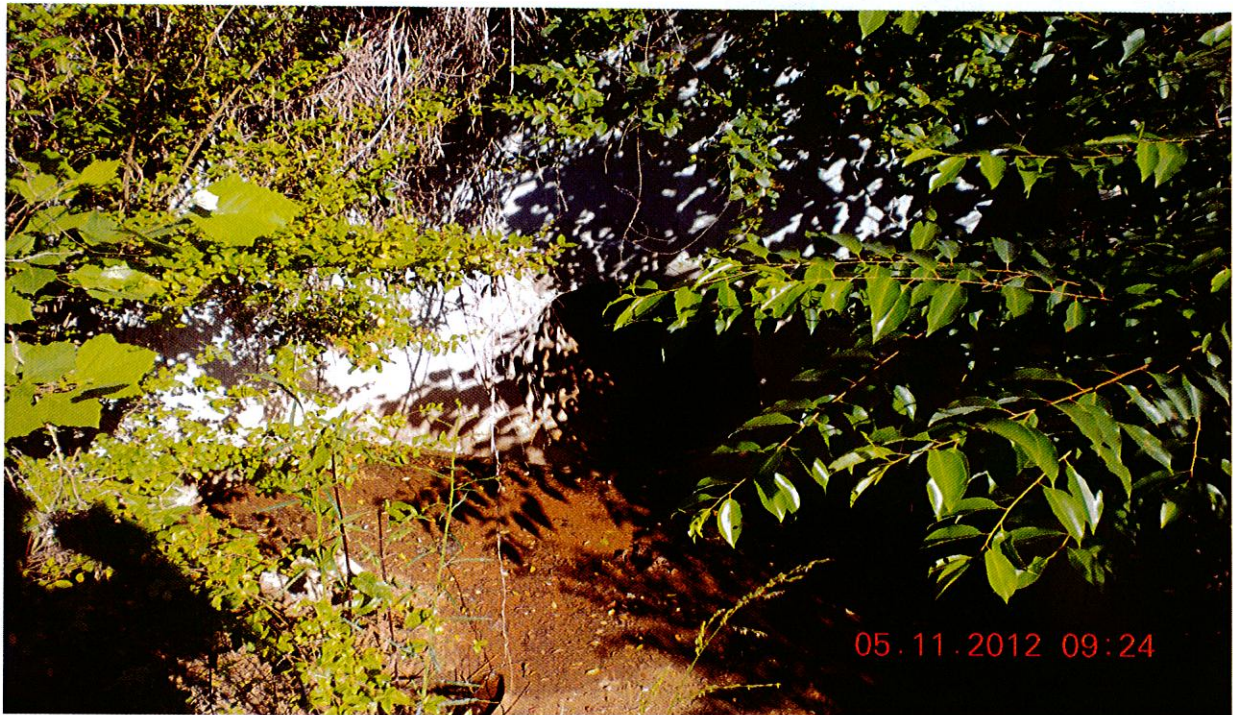
Photograph 3: Photograph shows outfall for the eastern sediment basin. The suspended clay particles mentioned in photograph 2 are being discharged into the unnamed tributary to Friar Branch.

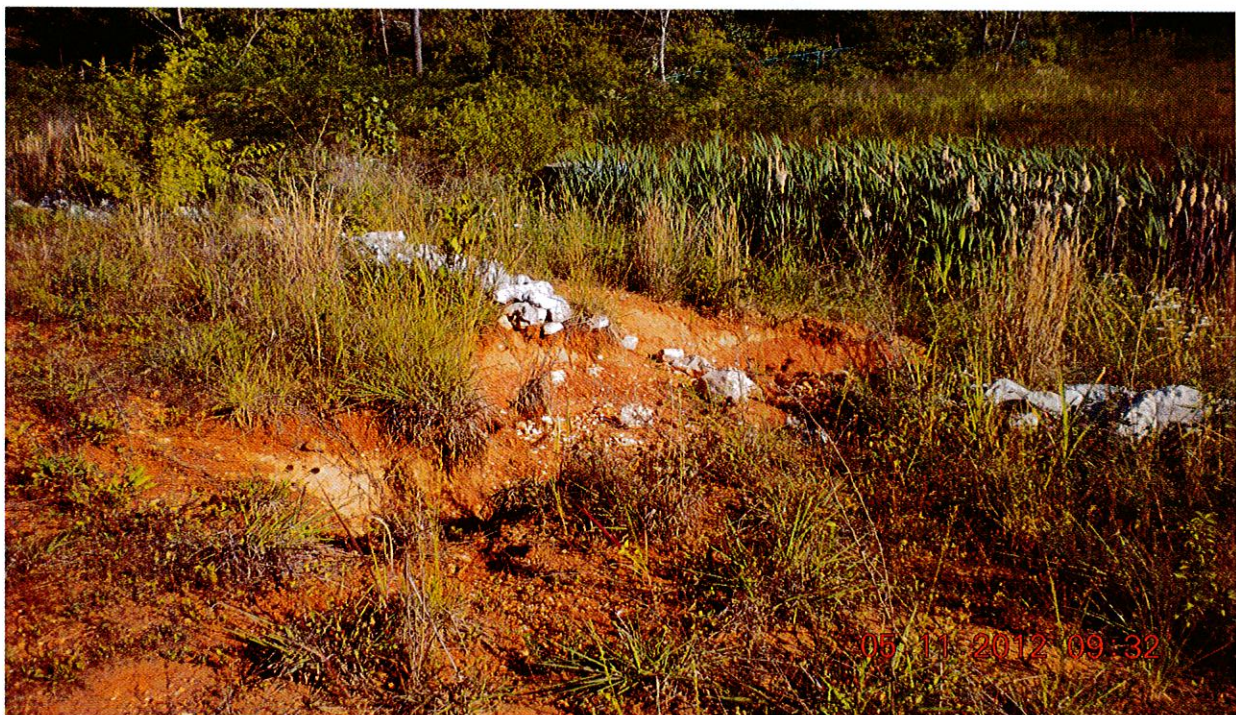
Photograph 4: Photograph showing erosion occurring to the bank of the western sediment basin. This area needs to be restabilized. Also, the sediment basin is in need of regular maintenance.
